Test report

| Test items | Coating hundred-cell test |
| Test object | SP-F310A-40P-RDM |
| Purpose of detection | Verify the paint level of SP-F310A-40P-RDM lamps |

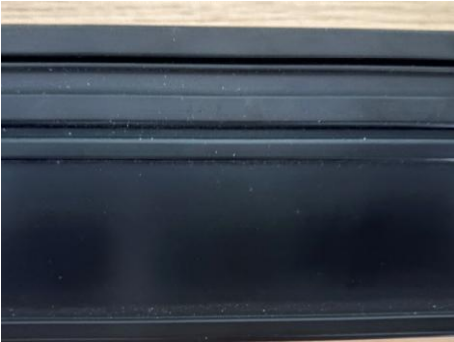
Test data:  
1. Record the state of the sample before the test.

The product has a smooth and traceless surface

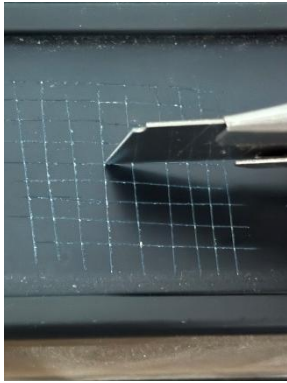
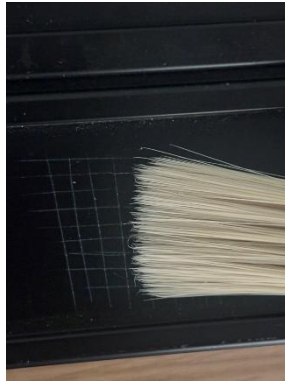
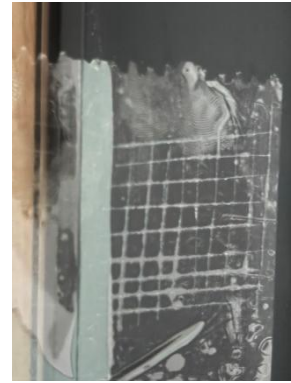
**Test process:**

2. Draw a line with a utility knife every 1mm interval in the area of 100mm<sup>2</sup> (the depth needs to see the substrate), cross mark 100 squares, use a brush to clean the paint surface of the square, paste it with tape or its compatible adhesive tape on the test area of the square, and then use the tape to tear away immediately and quickly in the vertical direction, the paint on the test surface shall not fall off more than 5%. After the test, use a magnifying glass to observe the paint of the lamp body and the surface of the tape

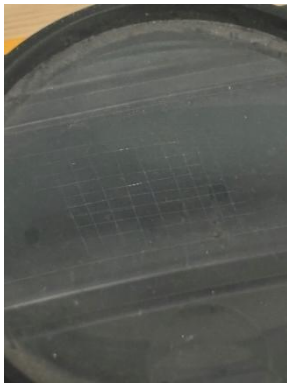
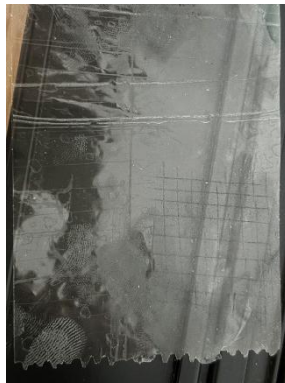
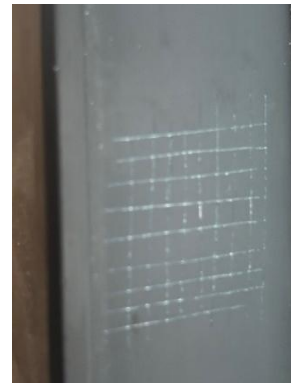
**Test results**

Through the appeal test data, it was proved that SP-F310A-40P-RDM did not fall off the paint surface of the lamp body after the coating 100 grid test.

Test final conclusion: SP-F310A-40P-RDM sample lamps can pass the 5B grade coating 100-cell test requirements; The results of this experiment are only responsible for the sample results.
